## INSTRUMENT SCIENCE REPORT

CAL/FOS-010 \ 9

TITLE: FOS Filter-Grating Wheel Repeatability (FOS CAL. Plan 10D)

DATE: Dec. 1984

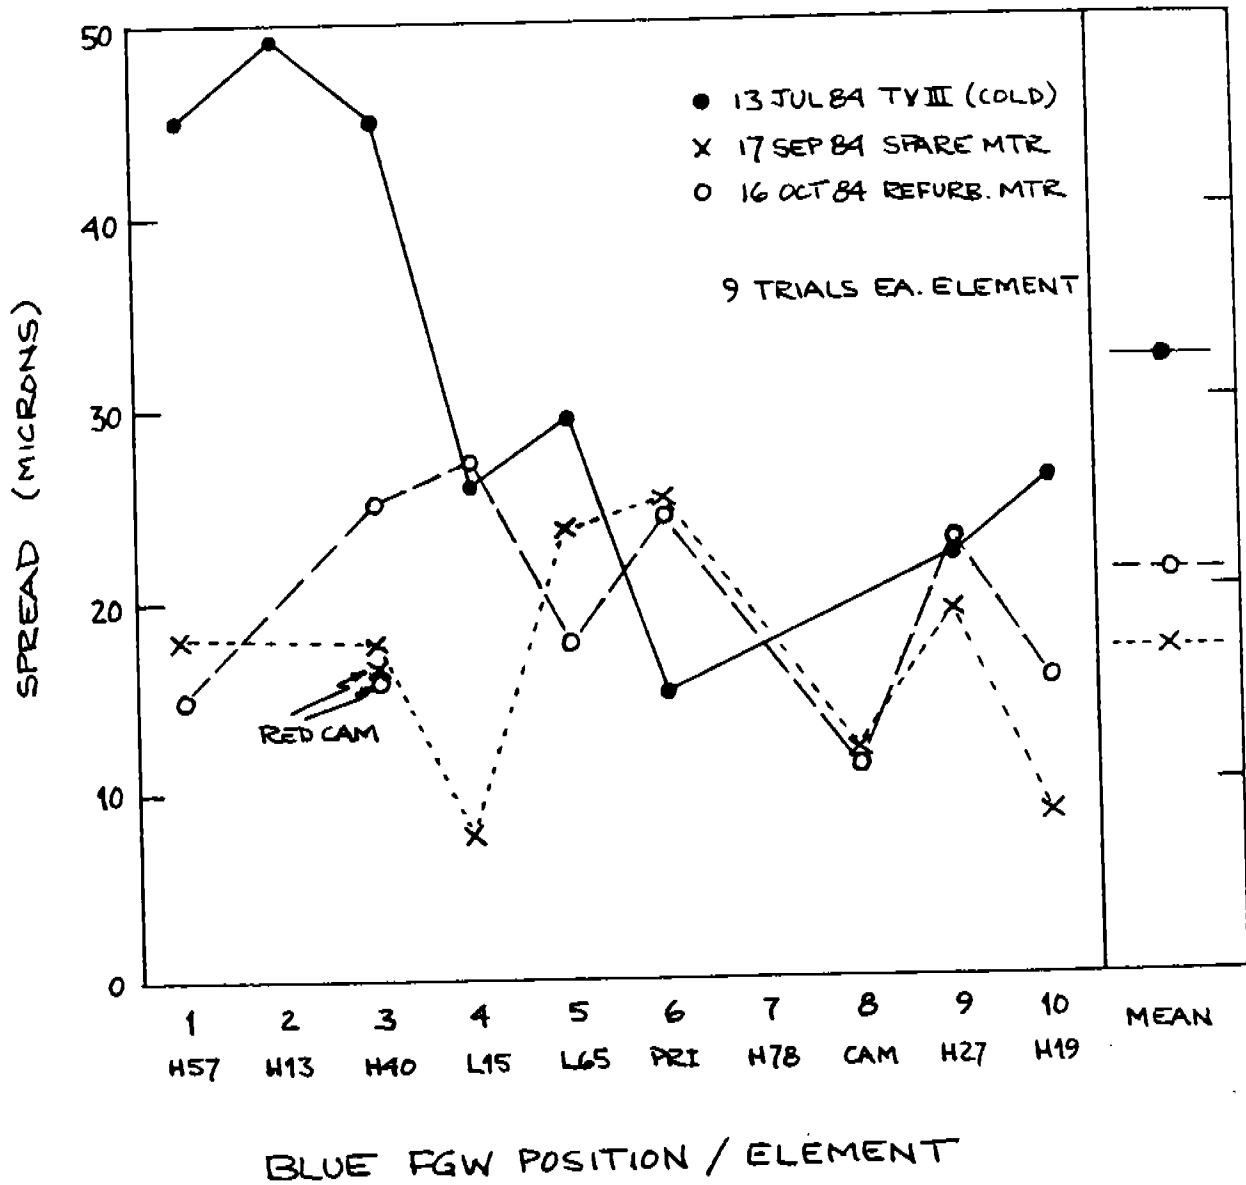
FIGURE 1.

The severity of the repeatability problem was realized during the TV III calibration in July 1984 (meas. #3 of Table 1), when systematic measurements were made which showed spreads in image positioning for some of the dispersers to be quite large. These data, obtained by moving the FGW nine times to each disperser, in semi-random order, are plotted in Figure 1 (along with some later measurements discussed below). The data appear to indicate a sinusoidal dependence of the repeatability (in the X direction) with element position around the wheel. Although the camera mirror was not measured in this test, an interpolation of the data at its position on the FGW indicates a spread of  $\sim 20\mu$  is to be expected, somewhat worse than the values measured in March 1983 in ambient calibration I.

since the standard procedure used for the results shown in Figure 1 was not run at ambient before the motor was removed. Nevertheless we can compare as follows:

\*Measurements also made of other elements, see Fig. 1.
